QUALITATIVE EROSION AND SEDIMENTATION INVESTIGATION MALINE CREEK

QUALITATIVE EROSION AND SEDIMENTATION INVESTIGATION MALINE CREEK CITY AND COUNTY OF ST. LOUIS, MISSOURI

Simons, Li & Associates, Inc. 3555 Stanford Road P.O. Box 1816 Fort Collins, CO 80522

July 30, 1985

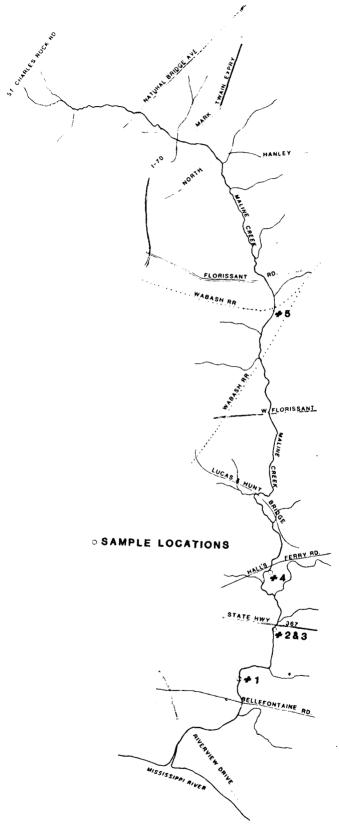
Figure 4.1. Locations of soil samples in Maline Creek watershed.

Soil samples of bed and bank material were taken at five locations along Maline Creek during the site visit. Figure 4.1 shows the approximate location where samples were taken. Analysis of the samples was made to determine their size distribution. Hydrometer analysis was utilized to determine the distribution of material passing the 200 sieve (.075 mm). Gradation curves developed for each sample are presented on Figure 4.2.

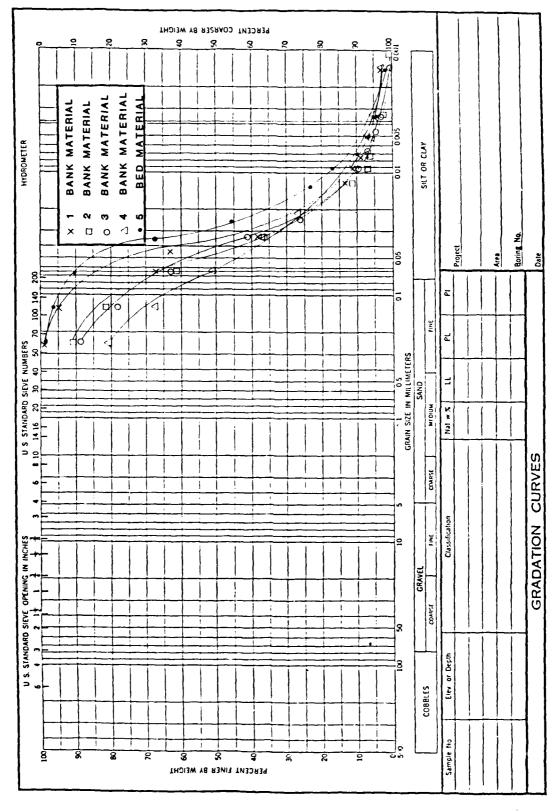
Figure 4.2. Gradation curves of soil samples.

The gradation curves for all the samples show that they are composed of approximately 70 to 90 percent by weight of material finer than the No. 200 sieve (.075 mm). Sample numbers 1, 2, 3, and 4 were taken of bank material along the creek. Sample No. 5 was taken of the stiff erosion resistant clay found in the bed of the channel. This may be correlative with the lower loess formation, the Roxana Loess, discussed in Section 4.3. Sample No. 5 was found to be composed of the finest material.

The clay content determined for each sample was found to be between 4 to 7 percent by weight. From field observations, it is believed that the clay

content is actually higher, on the order of 20 percent by weight. The low clay content determined by the hydrometery analysis is thought to be due to inadequate dispersion of clay particles.

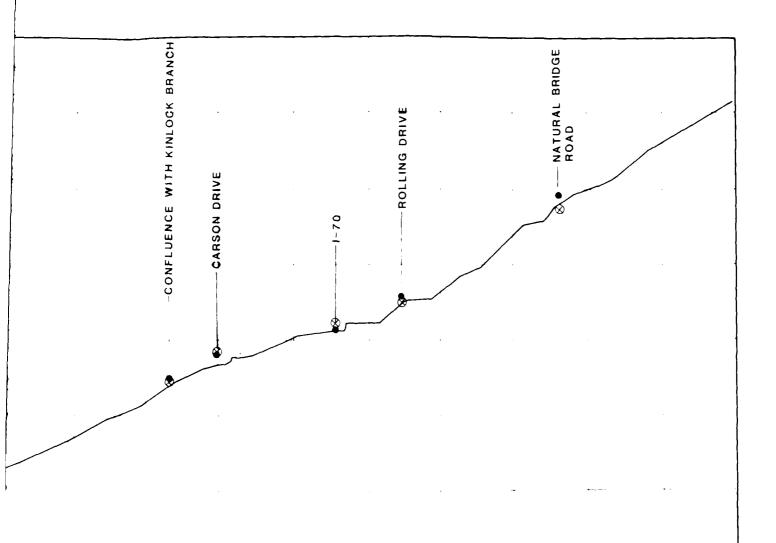
As can be seen in Figure 4.3a, the general trend of Maline Creek is an overall degradation of the channel profile. The channel bed has eroded between one to three feet over most of its length. The overall erosion of the channel profile indicates a deficit of available sediment compared to the transport capacity of the stream. The large amount of urban area in the watershed has reduced available sediment and increased the runoff and consequent sediment transport capacity of the stream.

At the confluence of Blackjack Creek, the channel was found not to be following the overall trend of channel degradation. The channel invert has aggraded approximately four feet in this area. This is believed to be a localized condition. The amount of sediment supplied by bank erosion occurring along Blackjack Creek is apparently greater than the sediment transport capacity of Maline Creek at their confluence, thus causing the observed change in bed elevation.

At Glen Owen Drive the channel bed has degraded approximately twice as much as was generally observed throughout the profile. The 1980 channel was seen to be approximately seven feet lower than that observed in 1963. This change is due to the cutoff downstream of a meander bend made during construction of the Lucas and Hunt Road extension. The length of the channel in this reach changed from a natural length of 3,600 feet to a channelized length of 1,800 feet. The shortening of the channel has steepened the slope causing higher channel velocities and increased erosion of the channel.

The drops observed at pipeline crossings in the Glen Owen Drive/ Lucas and Hunt area indicated that these structures are acting somewhat like grade control structures. The amount of degradation that might have occurred through this reach if these structures did not exist is estimated to be between three and five feet.

Only slight increases in degradation were observed between 1985 and 1980 channel data. This is thought to be due to an erosion-resistant clay layer which the channel has incised over much of its length. Additionally, the numerous concrete encased sewer lines which cross the creek tend to act as grade controls.
